Machine diagnosis report

Customer: XXXXXX
Measuring engineer, date, time: N. Mischol, XX.XX.XX
Test system: PeakStore
operator: XXXXXXXXXXXX
Object, type, ser. no.: XXXXXX, main gearbox
Gear unit supplier, type, ser. no.: XXXXXXXXXXXX
Generator supplier, type, ser. no.: XXXXXX, left
Generator supplier, type, ser. no.: XXXXXX, right
Power during measurement: up to full load
Generator speed: about 601 min⁻¹
Consultant GfM: Dipl.-Ing. Norman Schröter
GfM No.: DXXXX
Number of pages: 7

Berlin, 14. July 2009

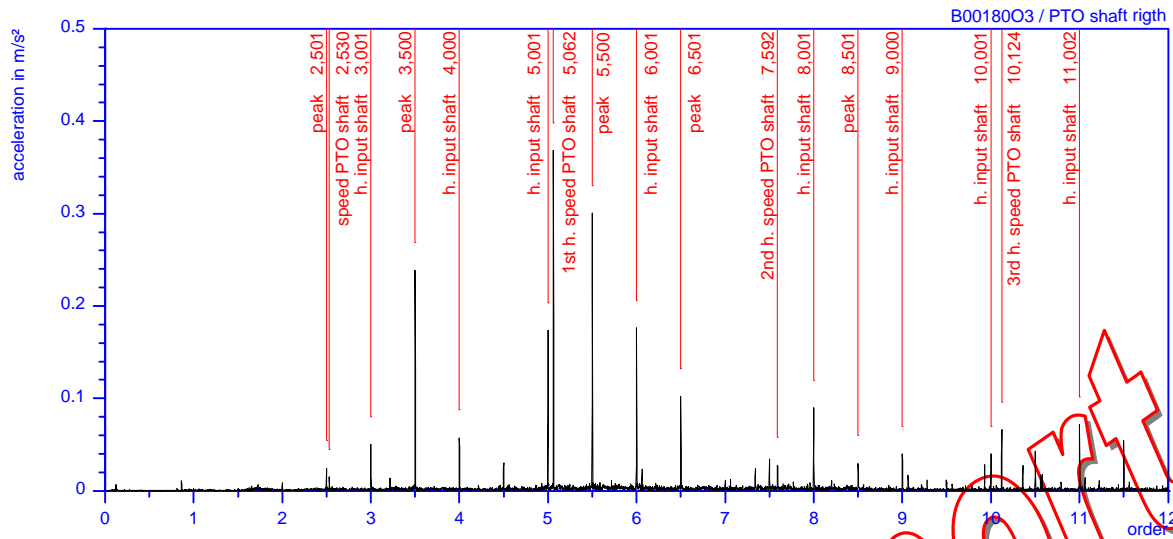
Fig. 4: Order spectrum, measured at the right PTO shaft, generator sided, radial

no.	found irregularities	trend	recommendation	$P_{\tau < 1a}$
general:				
01	The peaks at the 2,501. order, 3,500. order, 5,500. order and so on (Fig. 4) can not be assigned to the kinematics.			
02	The peak at the 1,226. order and the harmonics (Fig. 7) can not be assigned to the kinematics.			
gear shafts:				
21	input shaft left			
22	input shaft right			
23	output shaft			
24	PTO shaft left	advice for fitting- or bearing seat problems or hitting particles (Fig. 7)	visual inspection, if possible	
25	PTO shaft right			
tooth meshing of gear unit:				
31	1st stage	advice for a revolving deviation of flank shapes (Fig. 1)		< 5 %
		advice for a local deviation of flank shapes at pinion (Fig. 2)		< 5 %
32	2nd stage	advice for a local deviation of flank shapes at pinion and wheel (Fig. 3)		< 5 %
gear unit bearings:				
41	input shaft left			
42	input shaft right			
43	output shaft			
44	PTO shaft left			
45	PTO shaft right	inner ring of bearing 7224B (Fig. 5), cage and rolling elements of bearing 7224B (Fig. 6)	bearing replacement as quickly as possible	50 %

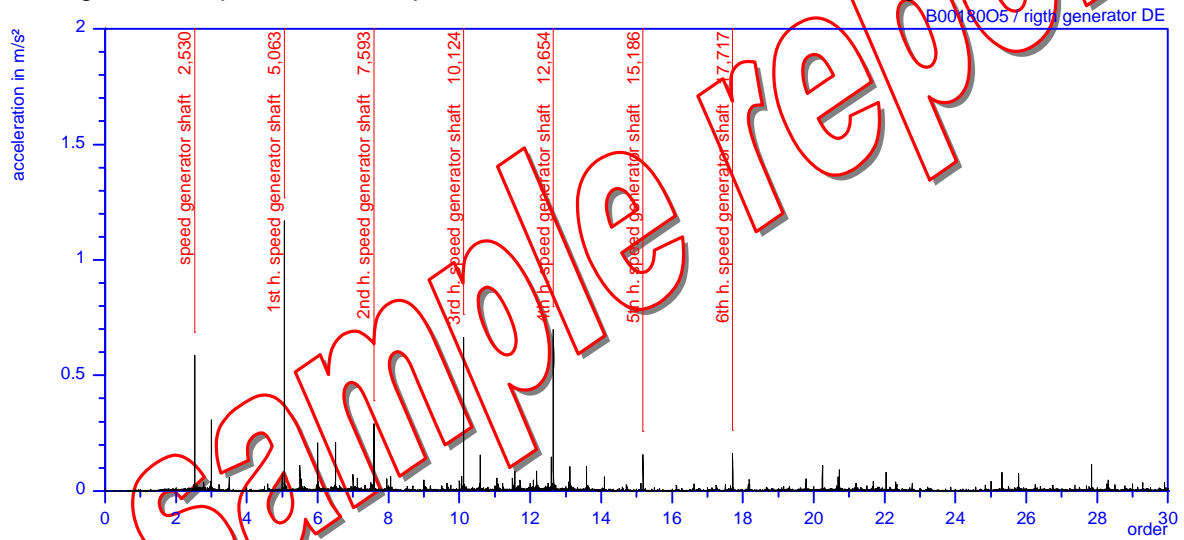
Fig. 8: Order spectrum, measured at the right generator, DE bearing, radial

generator left:				
51	shaft	advice for unbalance and misalignment (Fig. 11)	unbalance should be checked	
52	DE bearing			
53	NDE bearing	inner ring of bearing 6328 (Fig. 12)		< 5 %
generator right:				
61	shaft	advice for unbalance and misalignment (Fig. 8)	unbalance should be checked	
62	DE bearing	cage and rolling elements of bearing NU232 (Fig. 10), inner ring and outer ring of bearing NU232 (Fig. 9)	visual inspection, if possible	20 %
63	NDE bearing
